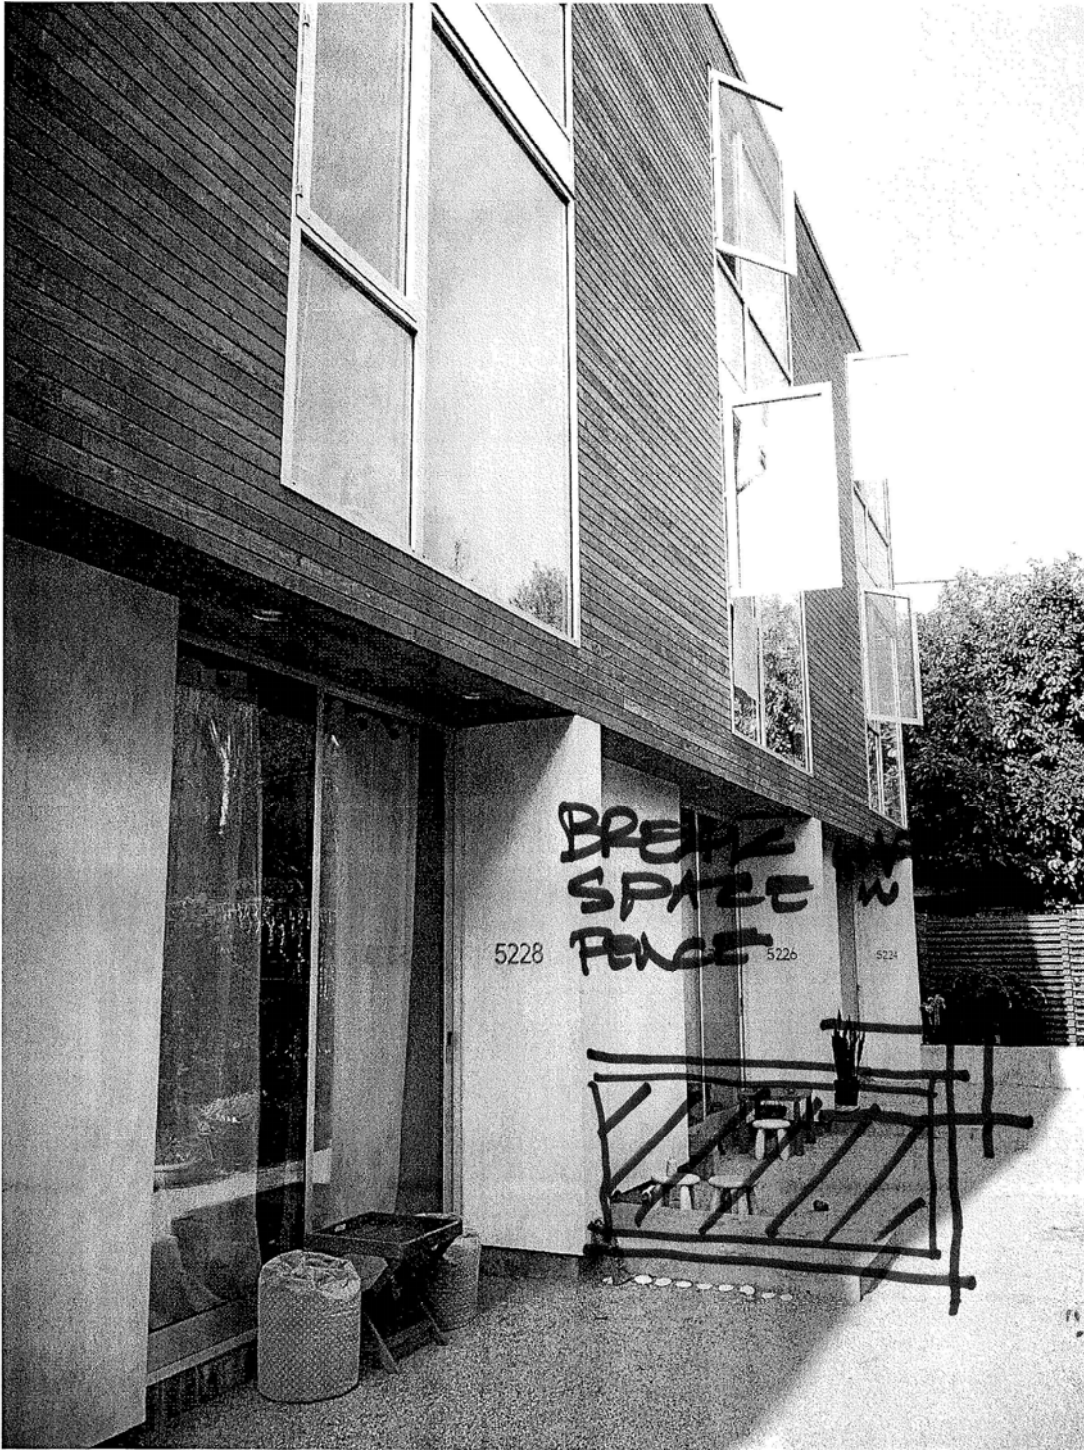
- The space could be broken-up with a low fence between each unit.

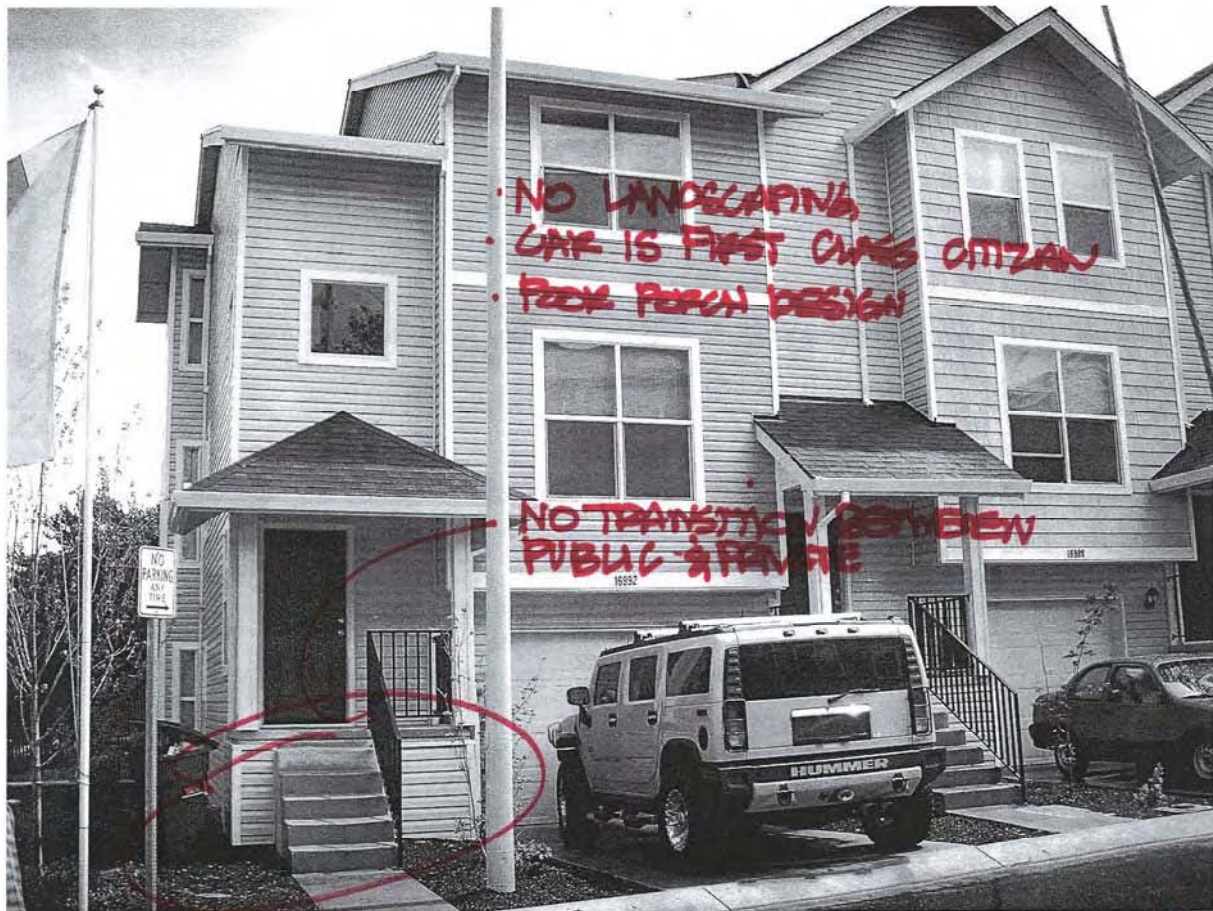
58

- There is no landscaping.
- The car is treated with more deference than the resident.
- The porch is of poor design.
- There is no transition between the public and private realm.

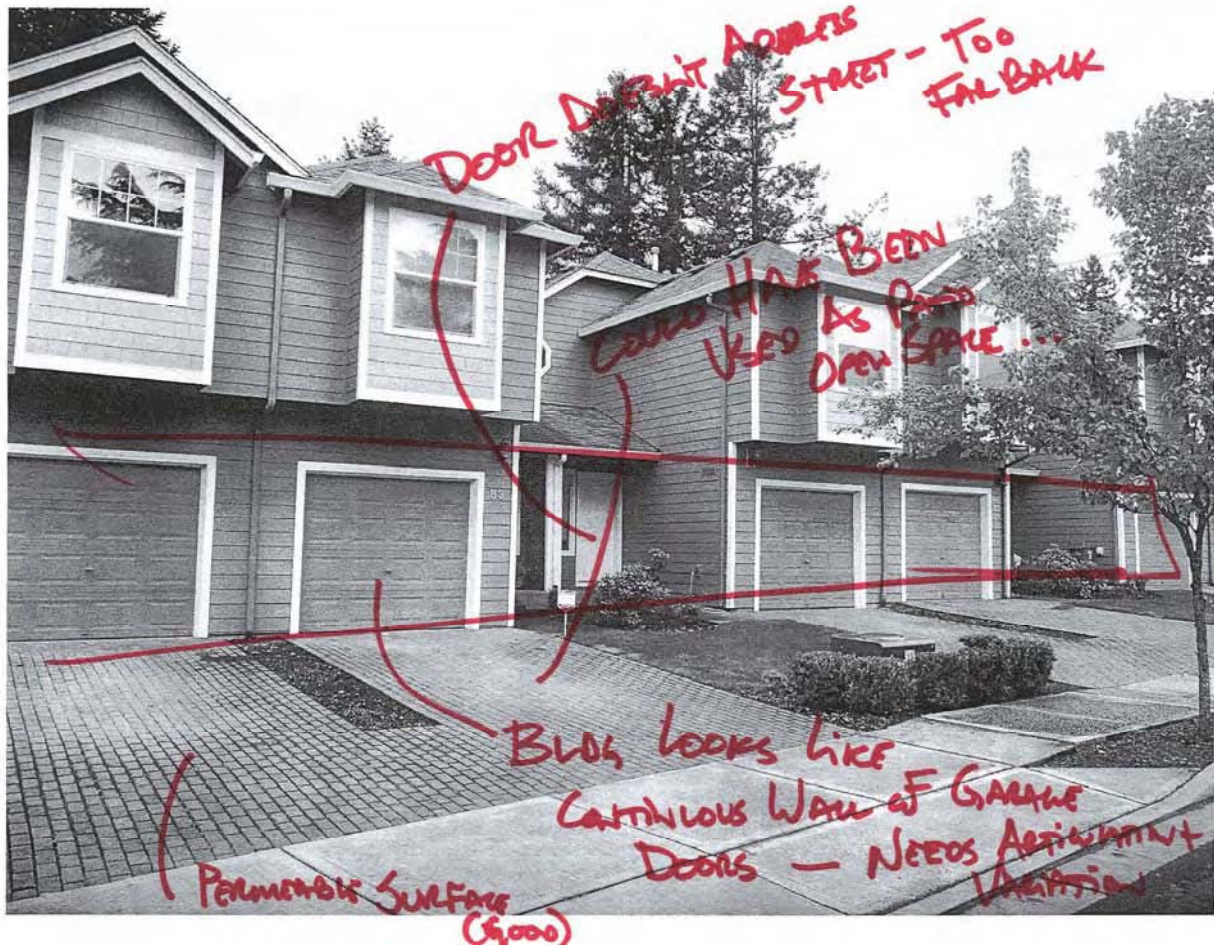
- The entry does not address the street since it is located so far back from the street.
- Part of the driveway could have been used as patio open space.
- The building looks like a continuous wall of garage doors; articulation and variation is needed.
- The use of a permeable surface for the driveway is a good design aspect.
